**Flood Control Project Maintenance  
Levee Inspections**  
**LMA District Cover Sheet**  
**Spring 2017 Levee Inspection Results**

**Levee District No. 0003 (Glenn County)**

**Levee Inspection Report By Mile - Spring 2017**

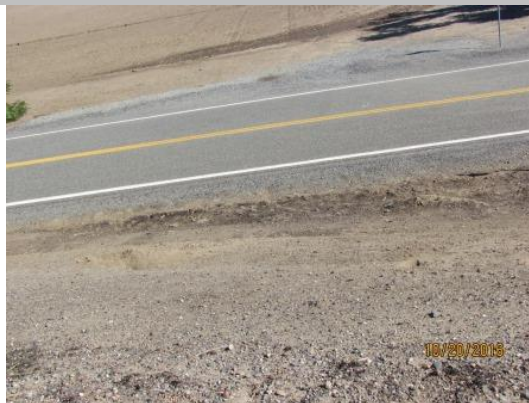
Photo 1 of 1 : SP\_2017\_LD0003\_27\_105\_20170315\_00059.jpg

LM Start	0.27	Rating **	M	Issue No.	105	
LM End	0.27	Issue Type +	Ma	Location *	LS	
Category	Earthen Levee			GPS Latitude/Longitude		
				Start	End	
Item	Animal Control			39.387413 °	39.387413 °	
				-121.991086 °	-121.991086 °	
DWR ID	DWR_LD0003_01_f_2016_105					
Comment Code						
A3 : No rodents visible, but rodent burrows visible; need to backfill and compact or grout burrows.						
Inspector Comment

View of the rodent holes along the landside slope.

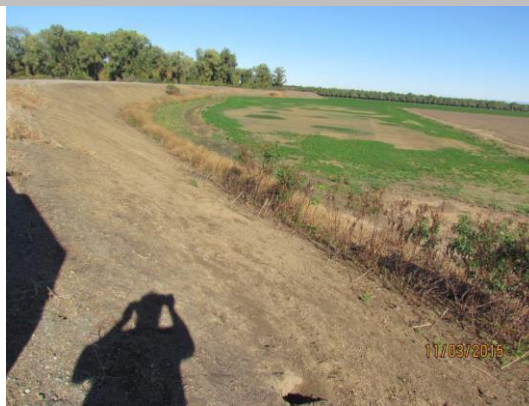
Photo 1 of 1 : SP\_2017\_LD0003\_27\_51\_20170315\_00028.jpg

LM Start	0.81	Rating **	U	Issue No.	51
LM End	0.91	Issue Type +	Ma	Location *	LS
Category	Earthen Levee			GPS Latitude/Longitude	
				Start	End
Item	Animal Control			39.388690 °	39.389867 °
				-121.999820 °	-122.000585 °
DWR ID	DWR_LD0003_01_f_2015_51				
Comment Code					
A3 : No rodents visible, but rodent burrows visible; need to backfill and compact or grout burrows.					
Inspector Comment

View of the rodent holes along the landside slope.

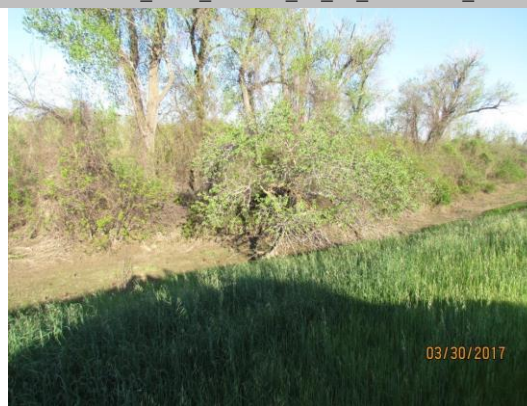
Photo 1 of 1 : SP\_2017\_LD0003\_27\_41\_20170330\_00099.jpg

LM Start	1.35	Rating **	M	Issue No.	41
LM End	1.35	Issue Type +	En	Location *	WS
Category	Earthen Levee			GPS Latitude/Longitude	
				Start	End
Item	Encroachments			39.395975 °	39.395975 °
				-122.001492 °	-122.001492 °
DWR ID	DWR_LD0003_01_s_2017_41				
Comment Code					
TR : Tree or limb					
Inspector Comment					
Remove the tree from the waterside slope and toe.

View of the tree on the waterside slope and toe.

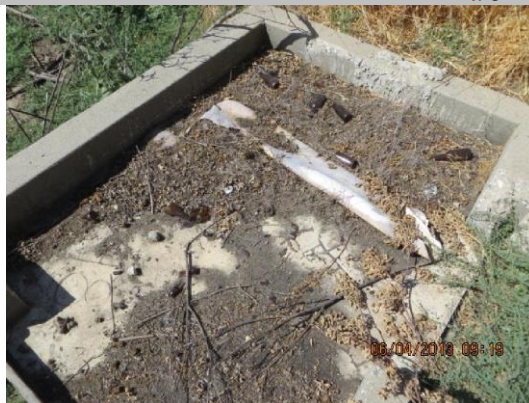
Photo 1 of 2 : UCIP\_SP\_2017\_14584\_24081.jpg

FS\_ID:14584  
DS\_ID:18829  
EP\_NO: 9919  
Repair Type: Non-Urgent  
Crossing Status: Indicator Found  
UCIP Comments: Appears abandoned. Verify it was done corectly.  
FIELD\_STRUCT\_DESC: \*Abandoned\* 24-inch corrugated metal pipe through the levee 16.0 feet below the crown, slide gate on waterward end. 5'X7' concrete distribution box at LS toe is filled with grout (ABO No. 9919-Mills). Originally included in the O+M manual (1960)  
FS Date: 6/4/2013

5'X7' concrete distribution box filled in with grout.

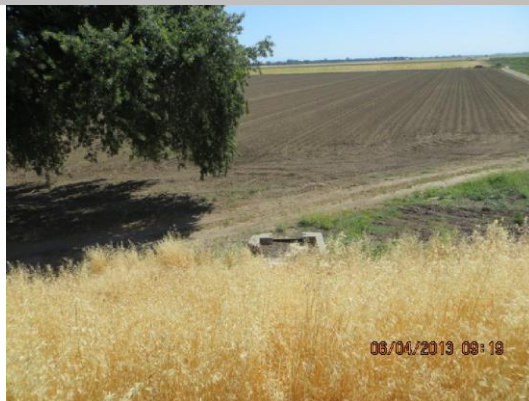
Photo 2 of 2 : UCIP\_SP\_2017\_14584\_24080.jpg

Distribution box on LS toe.

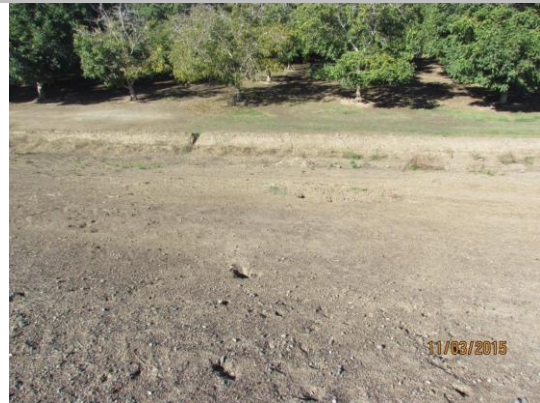
Photo 1 of 1 : SP\_2017\_LD0003\_27\_59\_20170315\_00031.jpg

LM Start	3.88	Rating **	M	Issue No.	59
LM End	3.88	Issue Type +	Ma	Location *	WS
Category	Earthen Levee			GPS Latitude/Longitude	
				Start	End
Item	Animal Control			39.425162 °	39.425162 °
				-121.990528 °	-121.990528 °
DWR ID	DWR_LD0003_01_f_2015_59				
Comment Code					
A3 : No rodents visible, but rodent burrows visible; need to backfill and compact or grout burrows.					
Inspector Comment

View of the rodent holes along the landside slope.

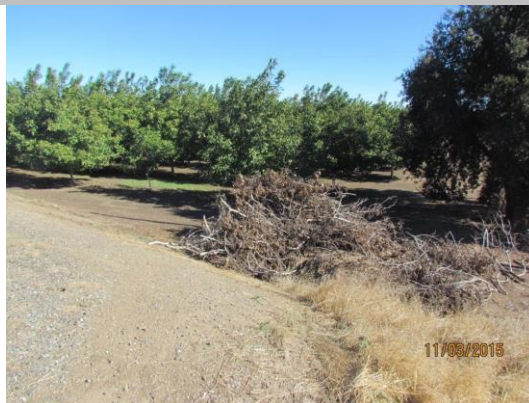
Photo 1 of 1 : SP\_2017\_LD0003\_27\_66\_20170315\_00038.jpg

LM Start	4.33	Rating **	M	Issue No.	66
LM End	4.33	Issue Type +	Ma	Location *	LS
Category	Earthen Levee			GPS Latitude/Longitude	
				Start	End
Item	Encroachments			39.430927 °	39.430927 °
				-121.987142 °	-121.987142 °
DWR ID	DWR_LD0003_01_f_2015_66				
Comment Code					
PR : Prunings					
Inspector Comment					
Remove the prunings from the landside slope.

View of the prunings along the landside toe.

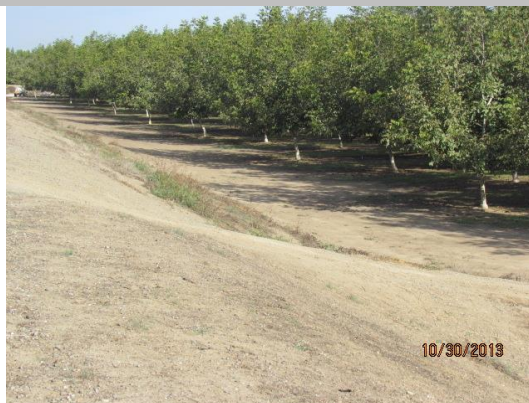
Photo 1 of 1 : SP\_2017\_LD0003\_27\_64\_20170315\_00036.jpg

LM Start	4.63	Rating **	U	Issue No.	64
LM End	4.68	Issue Type +	Ma	Location *	LS
Category	Earthen Levee			GPS Latitude/Longitude	
				Start	End
Item	Animal Control			39.435205 °	39.435855 °
				-121.988097 °	-121.988252 °
DWR ID	DWR_LD0003_01_f_2013_64				
Comment Code					
A3 : No rodents visible, but rodent burrows visible; need to backfill and compact or grout burrows.					
Inspector Comment

View of the rodent activity along the landside slope.

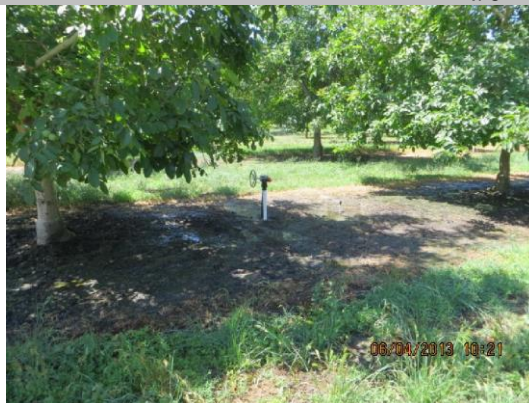
Photo 1 of 3 : UCIP\_SP\_2017\_15163\_24902.jpg

Possible shutoff valve on WS toe.

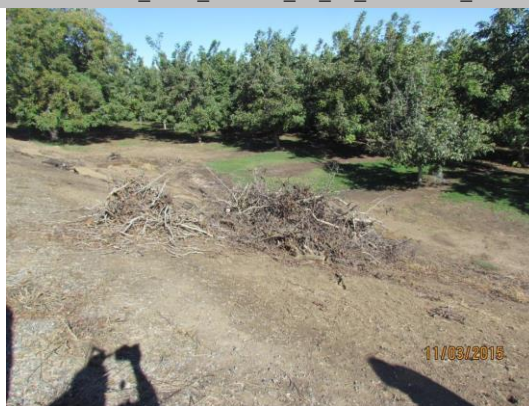
Photo 1 of 1 : SP\_2017\_LD0003\_27\_69\_20170315\_00040.jpg

LM Start	5.06	Rating **	M	Issue No.	69
LM End	5.06	Issue Type +	Ma	Location *	LS
Category	Earthen Levee			GPS Latitude/Longitude	
				Start	End
Item	Encroachments			39.441057 °	39.441057 °
				-121.990458 °	-121.990458 °
DWR ID	DWR_LD0003_01_f_2015_69				
Comment Code					
PR : Prunings					
Inspector Comment					
Remove the prunings from the landside slope.

View of the prunings along the landside slope.

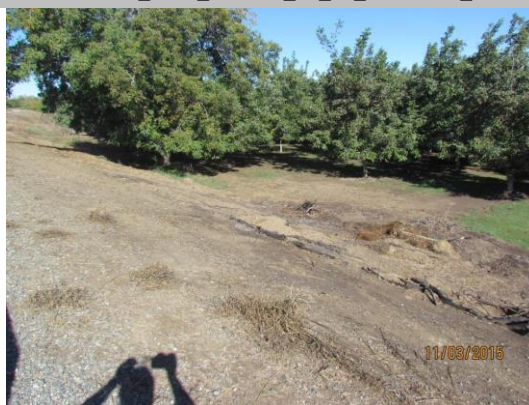
Photo 1 of 1 : SP\_2017\_LD0003\_27\_21\_20170315\_00014.jpg

LM Start	5.06	Rating **	U	Issue No.	21
LM End	5.25	Issue Type +	Ma	Location *	LS
Category	Earthen Levee			GPS Latitude/Longitude	
				Start	End
Item	Animal Control			39.441128 °	39.443793 °
				-121.990475 °	-121.991297 °
DWR ID	DWR_LD0003_01_f_2015_21				
Comment Code					
A3 : No rodents visible, but rodent burrows visible; need to backfill and compact or grout burrows.					
Inspector Comment

View of the rodent holes along the landside slope.

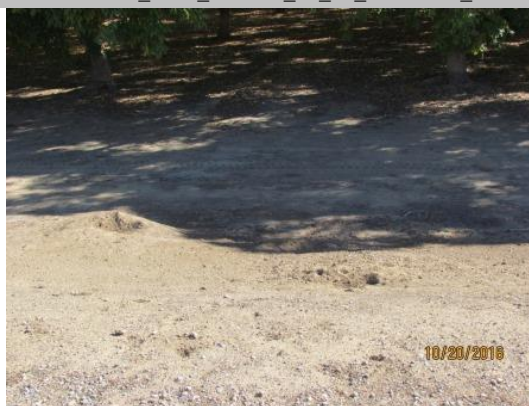
Photo 1 of 1 : SP\_2017\_LD0003\_27\_62\_20170315\_00034.jpg

LM Start	5.53	Rating **	U	Issue No.	62
LM End	5.62	Issue Type +	Ma	Location *	LS
Category	Earthen Levee			GPS Latitude/Longitude	
				Start	End
Item	Animal Control			39.447900 °	39.449115 °
				-121.991748 °	-121.991873 °
DWR ID	DWR_LD0003_01_f_2013_62				
Comment Code					
A3 : No rodents visible, but rodent burrows visible; need to backfill and compact or grout burrows.					
Inspector Comment

View of the rodent holes along the landside slope.

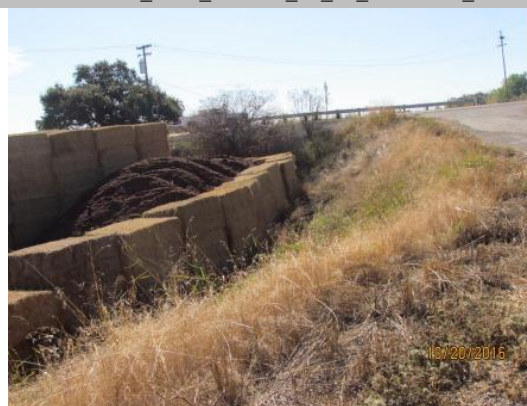
Photo 1 of 1 : SP\_2017\_LD0003\_27\_99\_20170315\_00055.jpg

LM Start	6.22	Rating **	U	Issue No.	99
LM End	6.22	Issue Type +	En	Location *	LS
Category	Earthen Levee			GPS Latitude/Longitude	
				Start	End
Item	Encroachments			39.457648 °	39.457648 °
				-121.993767 °	-121.993767 °
DWR ID	DWR_LD0003_01_f_2016_99				
Comment Code					
DE : Debris					
Inspector Comment					
Straw bales at the landside toe.

View of the straw bales along the landside toe.

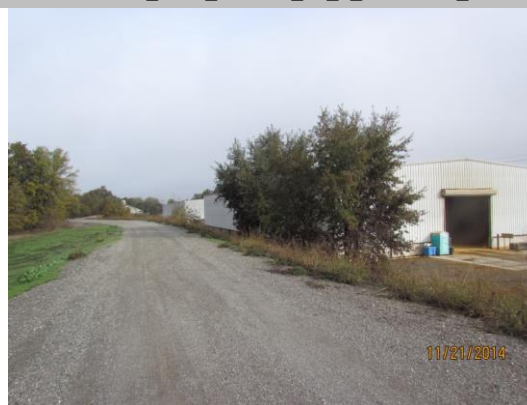
Photo 1 of 1 : SP\_2017\_LD0003\_27\_7\_20170315\_00005.jpg

LM Start	6.24	Rating **	M	Issue No.	7
LM End	6.38	Issue Type +	Ma	Location *	LS
Category	Earthen Levee			GPS Latitude/Longitude	
				Start	End
Item	Trim / Thin Trees			39.457968 °	39.459955 °
				-121.993712 °	-121.993512 °
DWR ID	DWR_LD0003_01_s_2012_7				
Comment Code					
T1 : Trim trees to at least five feet above ground level.					
Inspector Comment

Trim the trees 5 feet for better visibility.

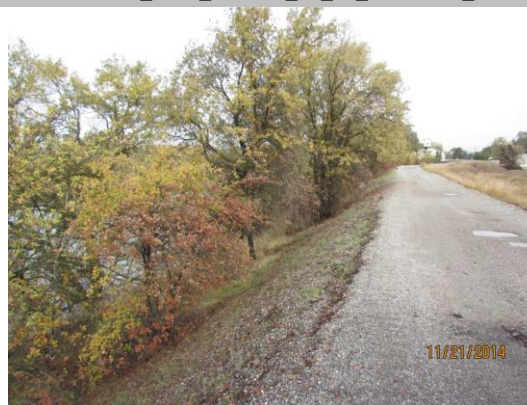
Photo 1 of 1 : SP\_2017\_LD0003\_27\_48\_20170315\_00022.jpg

LM Start	6.29	Rating **	M	Issue No.	48
LM End	6.38	Issue Type +	Ma	Location *	WS
Category	Earthen Levee			GPS Latitude/Longitude	
				Start	End
Item	Trim / Thin Trees			39.458587 °	39.459912 °
				-121.993777 °	-121.993592 °
DWR ID	DWR_LD0003_01_s_2012_48				
Comment Code					
T1 : Trim trees to at least five feet above ground level.					
Inspector Comment

Trim trees 5 feet above ground for better visibility.

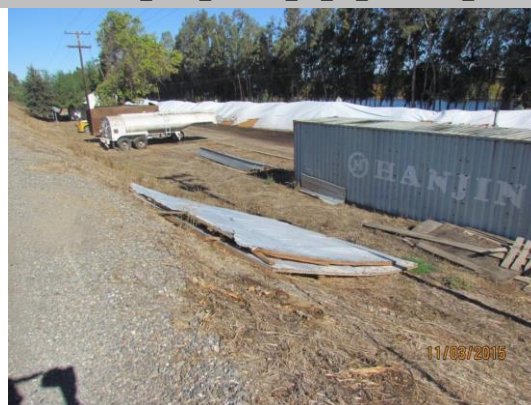
Photo 1 of 1 : SP\_2017\_LD0003\_27\_74\_20170315\_00044.jpg

LM Start	6.43	Rating **	U	Issue No.	74
LM End	6.43	Issue Type +	En	Location *	LS
Category	Earthen Levee			GPS Latitude/Longitude	
				Start	End
Item	Encroachments			39.460563 °	39.460563 °
				-121.993195 °	-121.993195 °
DWR ID	DWR_LD0003_01_f_2015_74				
Comment Code					
DE : Debris					
Inspector Comment					
Remove the metal roof from the landside slope.

View of the metal roof laying on the landside slope.

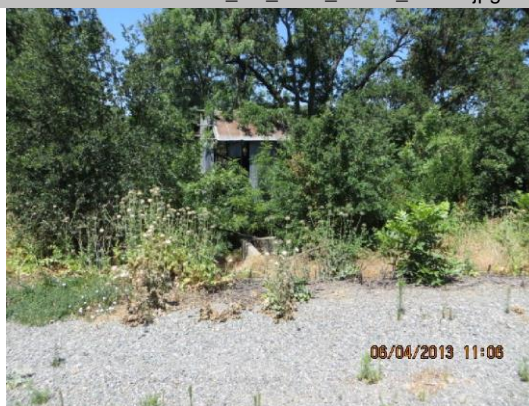
Photo 1 of 3 : UCIP\_SP\_2017\_14664\_24162.jpg

Pumphouse and 7'X12' concrete box on WS slope.

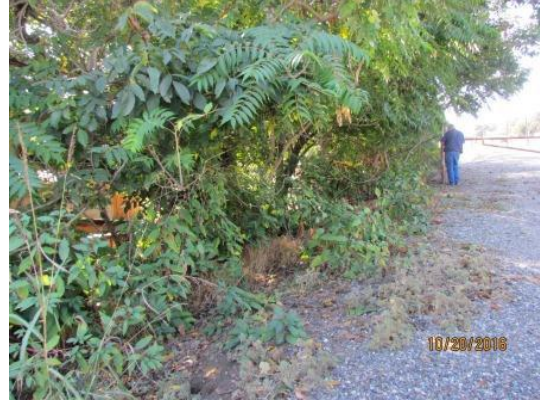
Photo 1 of 1 : SP\_2017\_LD0003\_27\_35\_20170315\_00019.jpg

LM Start	6.75	Rating **	M	Issue No.	35
LM End	6.75	Issue Type +	Ma	Location *	LS
Category	Earthen Levee			GPS Latitude/Longitude	
				Start	End
Item	Trim / Thin Trees			39.465013 °	39.465013 °
				-121.991455 °	-121.991455 °
DWR ID	DWR_LD0003_01_s_2012_35				
Comment Code					
T1 : Trim trees to at least five feet above ground level.					
Inspector Comment

View of the trees that are hanging over the landside slope of the levee.

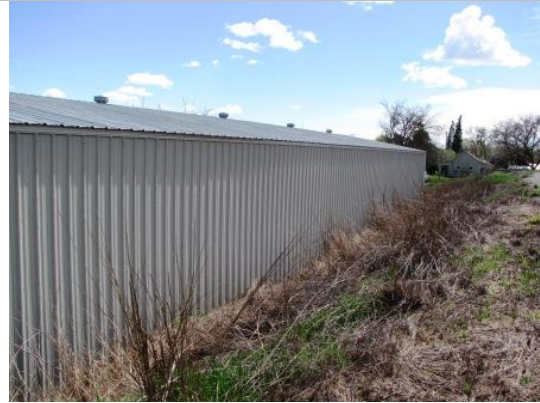
Photo 1 of 1 : SP\_2017\_LD0003\_27\_42\_20170315\_00021.jpg

LM Start	6.79	Rating **	M	Issue No.	42
LM End	6.79	Issue Type +	En	Location *	LS
Category	Earthen Levee			GPS Latitude/Longitude	
				Start	End
Item	Encroachments			39.465567 °	39.465595 °
				-121.991415 °	-121.991412 °
DWR ID	DWR_LD0003_01_s_2012_42				
Comment Code					
BU : Building					
Inspector Comment

View of the building along the landside toe.

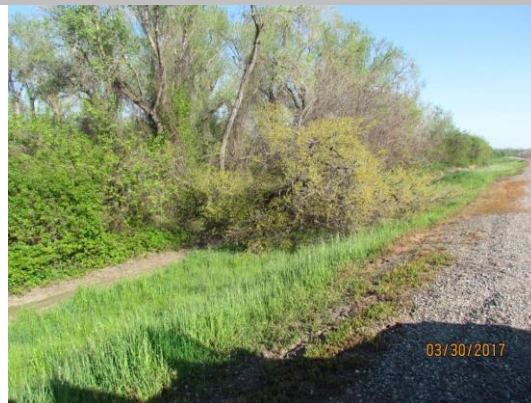
Photo 1 of 1 : SP\_2017\_LD0003\_27\_47\_20170330\_00104.jpg

LM Start	6.91	Rating **	M	Issue No.	47
LM End	6.91	Issue Type +	En	Location *	WS
Category	Earthen Levee			GPS Latitude/Longitude	
				Start	End
Item	Encroachments			39.467358 °	39.467358 °
				-121.991333 °	-121.991333 °
DWR ID	DWR_LD0003_01_s_2017_47				
Comment Code					
TR : Tree or limb					
Inspector Comment					
Remove the tree from the waterside slope and toe.

View of the tree on the waterside slope and toe.

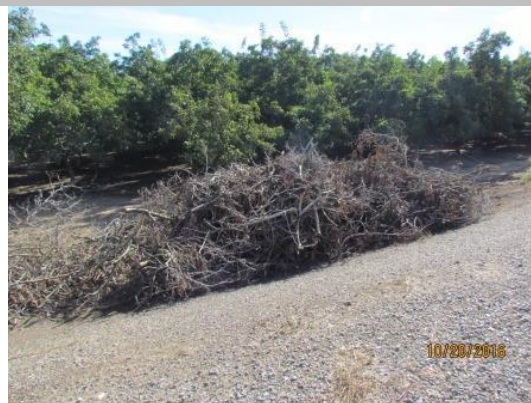
Photo 1 of 1 : SP\_2017\_LD0003\_27\_95\_20170315\_00053.jpg

LM Start	7.05	Rating **	M	Issue No.	95
LM End	7.05	Issue Type +	En	Location *	LS
Category	Earthen Levee			GPS Latitude/Longitude	
				Start	End
Item	Encroachments			39.469287 °	39.469287 °
				-121.991239 °	-121.991239 °
DWR ID	DWR_LD0003_01_f_2016_95				
Comment Code					
PR : Prunings					
Inspector Comment					
Remove the prunings from the landside toe.

View of the prunings along the landside toe.

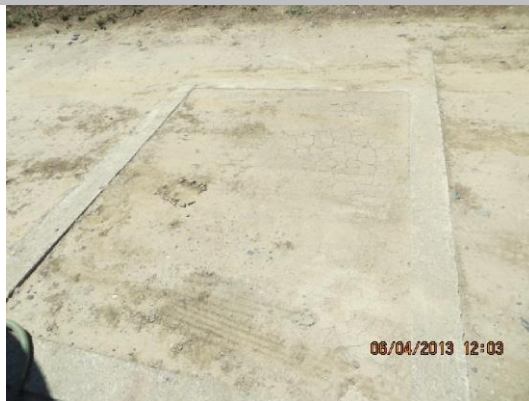
Photo 2 of 2 : UCIP\_SP\_2017\_14686\_24183.jpg

Soil filled concrete distribution box on LS toe.

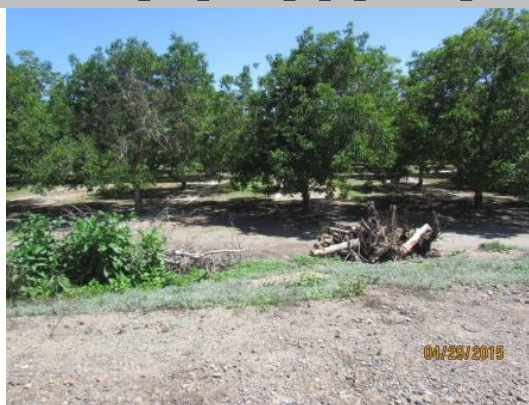
Photo 1 of 1 : SP\_2017\_LD0003\_27\_37\_20170315\_00020.jpg

LM Start	7.36	Rating **	M	Issue No.	37
LM End	7.36	Issue Type +	En	Location *	LS
Category	Earthen Levee			GPS Latitude/Longitude	
				Start	End
Item	Encroachments			39.473793 °	39.473793 °
				-121.991208 °	-121.991208 °
DWR ID	DWR_LD0003_01_s_2012_37				
Comment Code					
PR : Prunings					
Inspector Comment					
Remove the prunings from the landside slope.

View of the prunings along the landside slope.

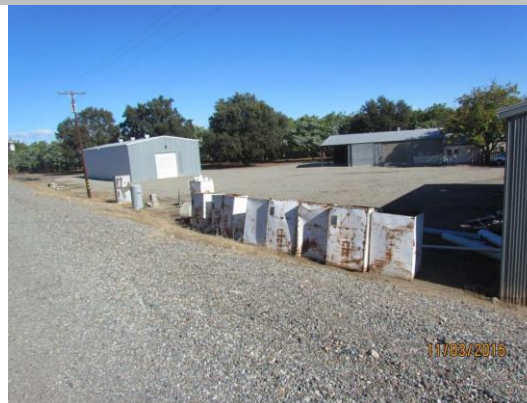
Photo 1 of 1 : SP\_2017\_LD0003\_27\_77\_20170315\_00046.jpg

LM Start	9.12	Rating **	M	Issue No.	77
LM End	9.12	Issue Type +	En	Location *	LS
Category	Earthen Levee			GPS Latitude/Longitude	
				Start	End
Item	Encroachments			39.497452 °	39.497452 °
				-121.987673 °	-121.987673 °
DWR ID	DWR_LD0003_01_f_2015_77				
Comment Code					
EQ : Equipment					
Inspector Comment					
Remove the metal boxes from the landside toe.

View of the metal boxes along the landside toe.

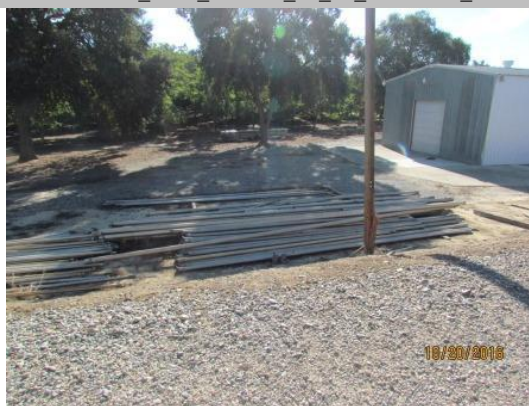
Photo 1 of 1 : SP\_2017\_LD0003\_27\_94\_20170315\_00052.jpg

LM Start	9.18	Rating **	U	Issue No.	94
LM End	9.18	Issue Type +	En	Location *	LS
Category	Earthen Levee			GPS Latitude/Longitude	
				Start	End
Item	Encroachments			39.498253 °	39.498253 °
				-121.987103 °	-121.987103 °
DWR ID	DWR_LD0003_01_f_2016_94				
Comment Code					
EQ : Equipment					
Inspector Comment

View of the ag pipes along the landside toe.

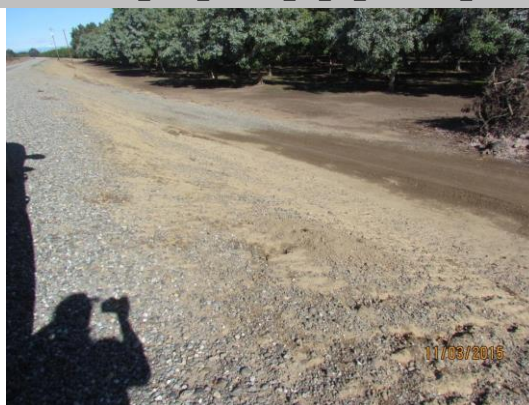
Photo 1 of 1 : SP\_2017\_LD0003\_27\_78\_20170315\_00047.jpg

LM Start	9.23	Rating **	M	Issue No.	78
LM End	9.23	Issue Type +	Ma	Location *	LS
Category	Earthen Levee			GPS Latitude/Longitude	
				Start	End
Item	Animal Control			39.498897 °	39.498897 °
				-121.986827 °	-121.986827 °
DWR ID	DWR_LD0003_01_f_2015_78				
Comment Code					
A1 : Exterminate rodents and backfill and compact or grout burrows.					
Inspector Comment

View of the rodent holes along the landside slope.

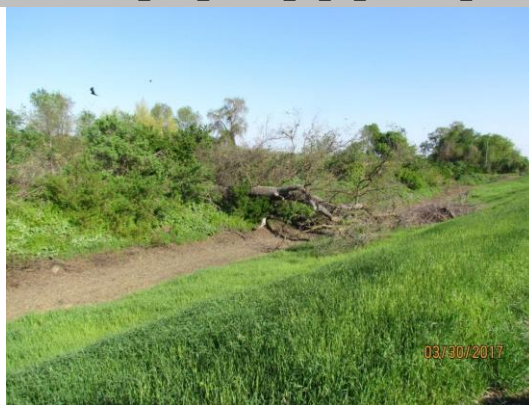
Photo 1 of 1 : SP\_2017\_LD0003\_27\_49\_20170330\_00105.jpg

LM Start	9.29	Rating **	M	Issue No.	49
LM End	9.29	Issue Type +	En	Location *	WS
Category	Earthen Levee			GPS Latitude/Longitude	
				Start	End
Item	Encroachments			39.499720 °	39.499720 °
				-121.986497 °	-121.986497 °
DWR ID	DWR_LD0003_01_s_2017_49				
Comment Code					
TR : Tree or limb					
Inspector Comment					
Remove the tree from the waterside slope and toe.

View of the tree along the waterside slope and toe.

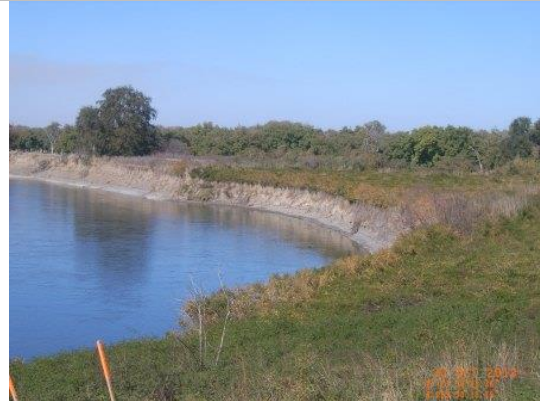
Photo 3 of 3 : SP\_2017\_LD0003\_27\_10\_20170315\_00009.jpg

Comment Code					
Inspector Comment					
2007 - Getting close to the levee. Bank is clayey silt with clayey/silty toe. 2008 - Looks a little worse at the upstream end. 2009 - Some new erosion and slumping. 2010 - Some new erosion upstream of site, actively eroding at low flow. New bank swallow colony noted. 2011 - Significant erosion since last year, with an estimated 10 to 15 feet of berm lost. Large sections of the bank have slumped off. 2012 - Part of the site appears to be stabilizing, but still minor slumping in other locations. 2013 - Minor new erosion at toe. 2015: Last observed in 2013. [2015 Site ID: SAC_172-0_L] On 3/25/2016, recent high water caused river to erode to within 10-20 feet of levee toe. Appears still somewhat active.

USACE 2013 Photo #3

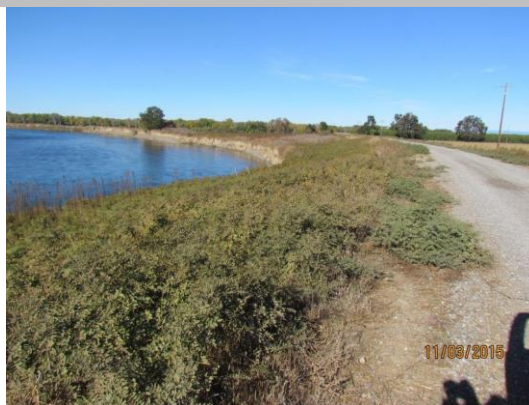
Photo 2 of 6 : SP\_2017\_LD0003\_27\_50\_20170315\_00024.jpg

LM Start	9.70	Rating **	U	Issue No.	50
LM End	9.70	Issue Type +	Ma	Location *	WS
Category	Earthen Levee			GPS Latitude/Longitude	
				Start	End
Item	Erosion / Bank Caving			39.505435 °	39.505435 °
				-121.984172 °	-121.984172 °
DWR ID	DWR_LD0003_01_f_2014_50				
Comment Code					
E2 : Schedule repair of erosion site prior to the next inspection.					
Inspector Comment					
Repair the erosion along the waterside toe. On 3/25/2016, recent high water caused river to erode to within 10-20 feet of levee toe. Appears still somewhat active.

View of the erosion along the waterside toe. Same site as the USACE erosion issue.

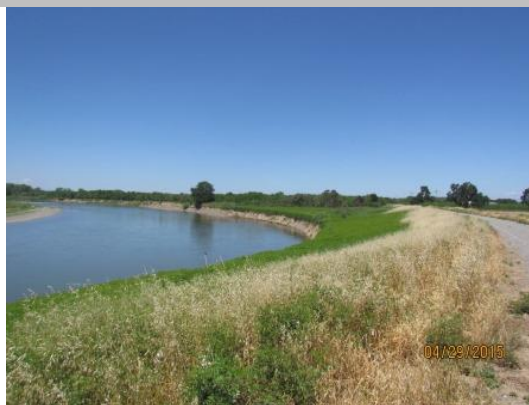
Photo 5 of 6 : SP\_2017\_LD0003\_27\_50\_20170315\_00027.jpg

LM Start	9.70	Rating **	U	Issue No.	50 (cont)	
LM End	9.70	Issue Type +	Ma	Location *	WS	
Category	Earthen Levee			GPS Latitude/Longitude		
				Start		End
Item	Erosion / Bank Caving			39.505435 °		39.505435 °
				-121.984172 °		-121.984172 °
DWR ID	DWR_LD0003_01_f_2014_50					
Comment Code						
E2 : Schedule repair of erosion site prior to the next inspection.						
Inspector Comment						
Repair the erosion along the waterside toe. On 3/25/2016, recent high water caused river to erode to within 10-20 feet of levee toe. Appears still somewhat active.

View of erosion along the waterside toe. Same site as the USACE erosion issue.

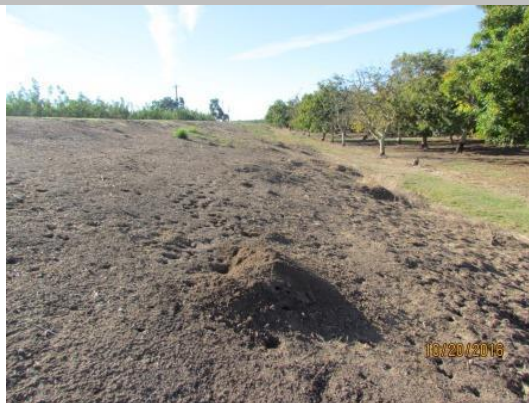
Photo 1 of 1 : SP\_2017\_LD0003\_27\_93\_20170315\_00051.jpg

LM Start	9.94	Rating **	M	Issue No.	93
LM End	10.03	Issue Type +	Ma	Location *	WS
Category	Earthen Levee			GPS Latitude/Longitude	
				Start	End
Item	Animal Control			39.508912 °	39.510199 °
				-121.983989 °	-121.983912 °
DWR ID	DWR_LD0003_01_f_2016_93				
Comment Code					
A1 : Exterminate rodents and backfill and compact or grout burrows.					
Inspector Comment

View of the rodent holes along the waterside slope.

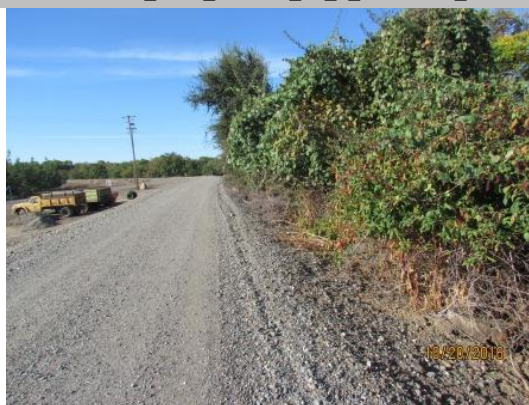
Photo 1 of 1 : SP\_2017\_LD0003\_27\_5\_20170315\_00003.jpg

LM Start	10.14	Rating **	M	Issue No.	5
LM End	10.24	Issue Type +	Ma	Location *	WS
Category	Earthen Levee			GPS Latitude/Longitude	
				Start	End
Item	Trim / Thin Trees			39.511788 °	39.512395 °
				-121.983750 °	-121.981975 °
DWR ID	DWR_LD0003_01_s_2012_5				
Comment Code					
T2 : Thin trees to allow visibility of the ground and room to flood fight.					
Inspector Comment

View of the dense vegetation along the waterside slope.

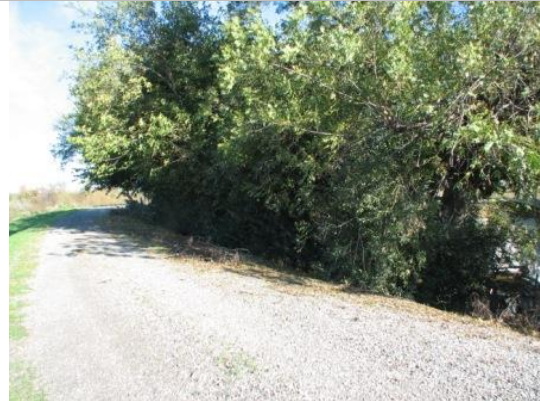
Photo 1 of 1 : SP\_2017\_LD0003\_27\_4\_20170315\_00002.jpg

LM Start	10.98	Rating **	U	Issue No.	4
LM End	11.01	Issue Type +	En	Location *	LS
Category	Earthen Levee			GPS Latitude/Longitude	
				Start	End
Item	Vegetation			39.522058 °	39.522480 °
				-121.979133 °	-121.979200 °
DWR ID	DWR_LD0003_01_s_2012_4				
Comment Code					
V6 : Landscaping					
Inspector Comment

View of the trees along the landside slope.
